Operation Alert #: 194

ISSUE DATE: March 5, 2024

MODEL AFFECTED: S-19, S-20 & S-21

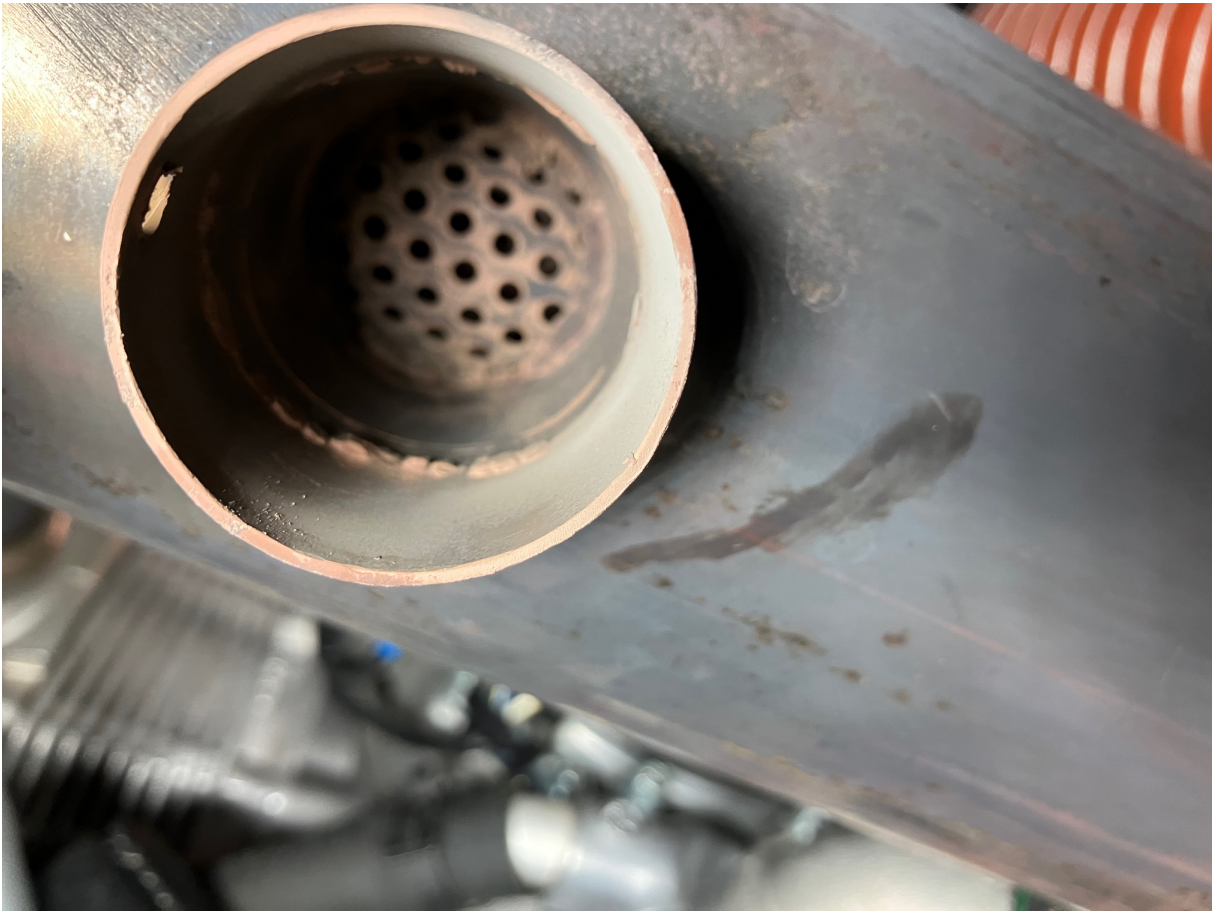
It has been reported that a muffler (KPEX0071), the exit for the tailpipe was restricted due to the perforated pipe not being removed where the exit pipe is welded to it. This restriction leads to high EGT's, excessive back pressure and loss of performance.

This image depicts the restriction. Note how you can see the exterior curvature of the perforated tubing.

Inspection of the muffler canister part number. KPEX0071 is required to assure the removal of the perforated tube has been removed at the main exhaust exit. To inspect: remove the exhaust exit pipe from the muffler canister and illuminate and inspect. There should be no perforated tubing where the exit pipe is welded to the perforated tube. A tape measure or ruler should insert approximately 3 3/8" (85+mm) deep into the muffler canister. If there is a perforated tube present near the exit surface, remove using a hole saw or a Dremel or similar tool. A significant increase in performance will be noted once the restriction is removed.

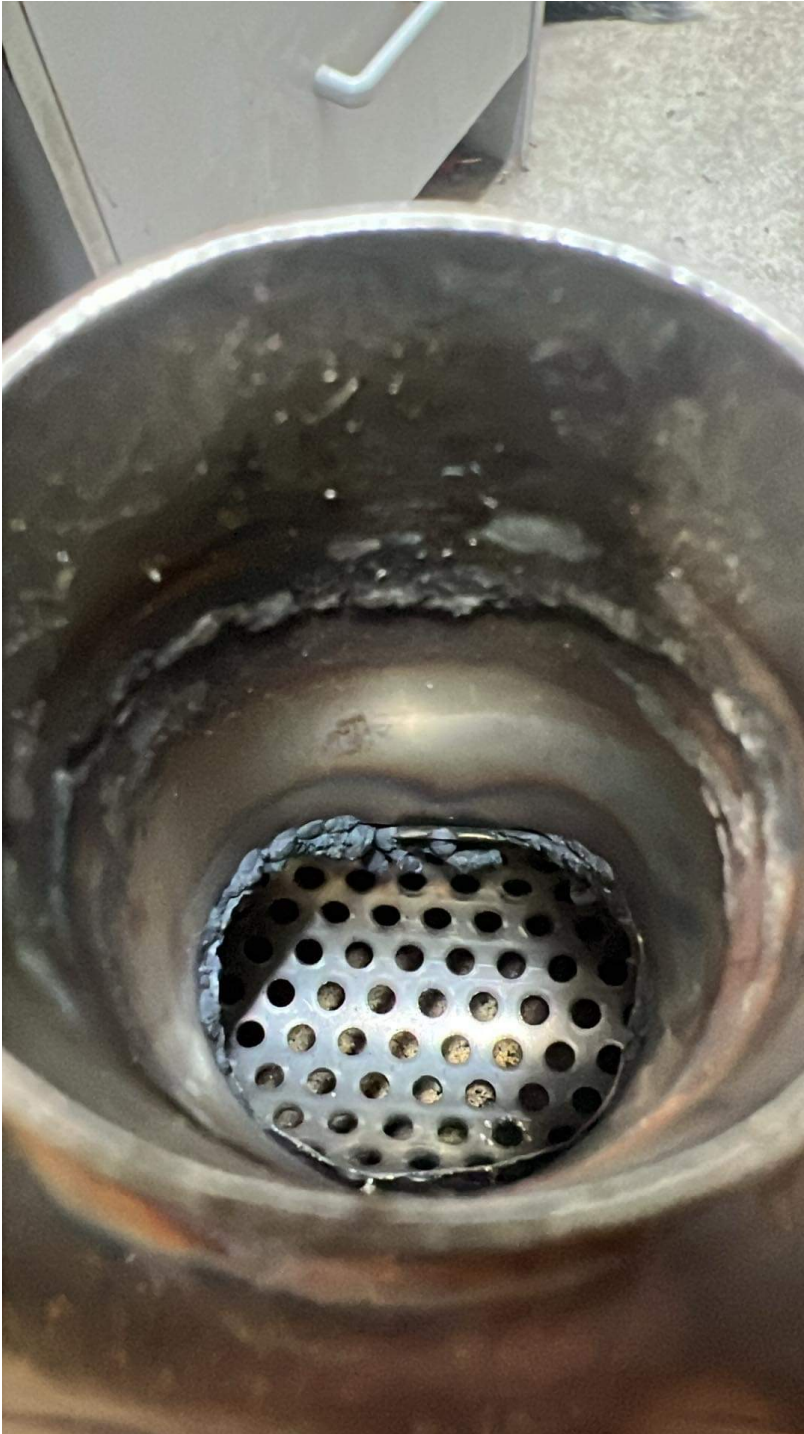
This is an image of a muffler that is correct. Note how the perforated tubing is cut away where the exit pipe joins the perforated tube.

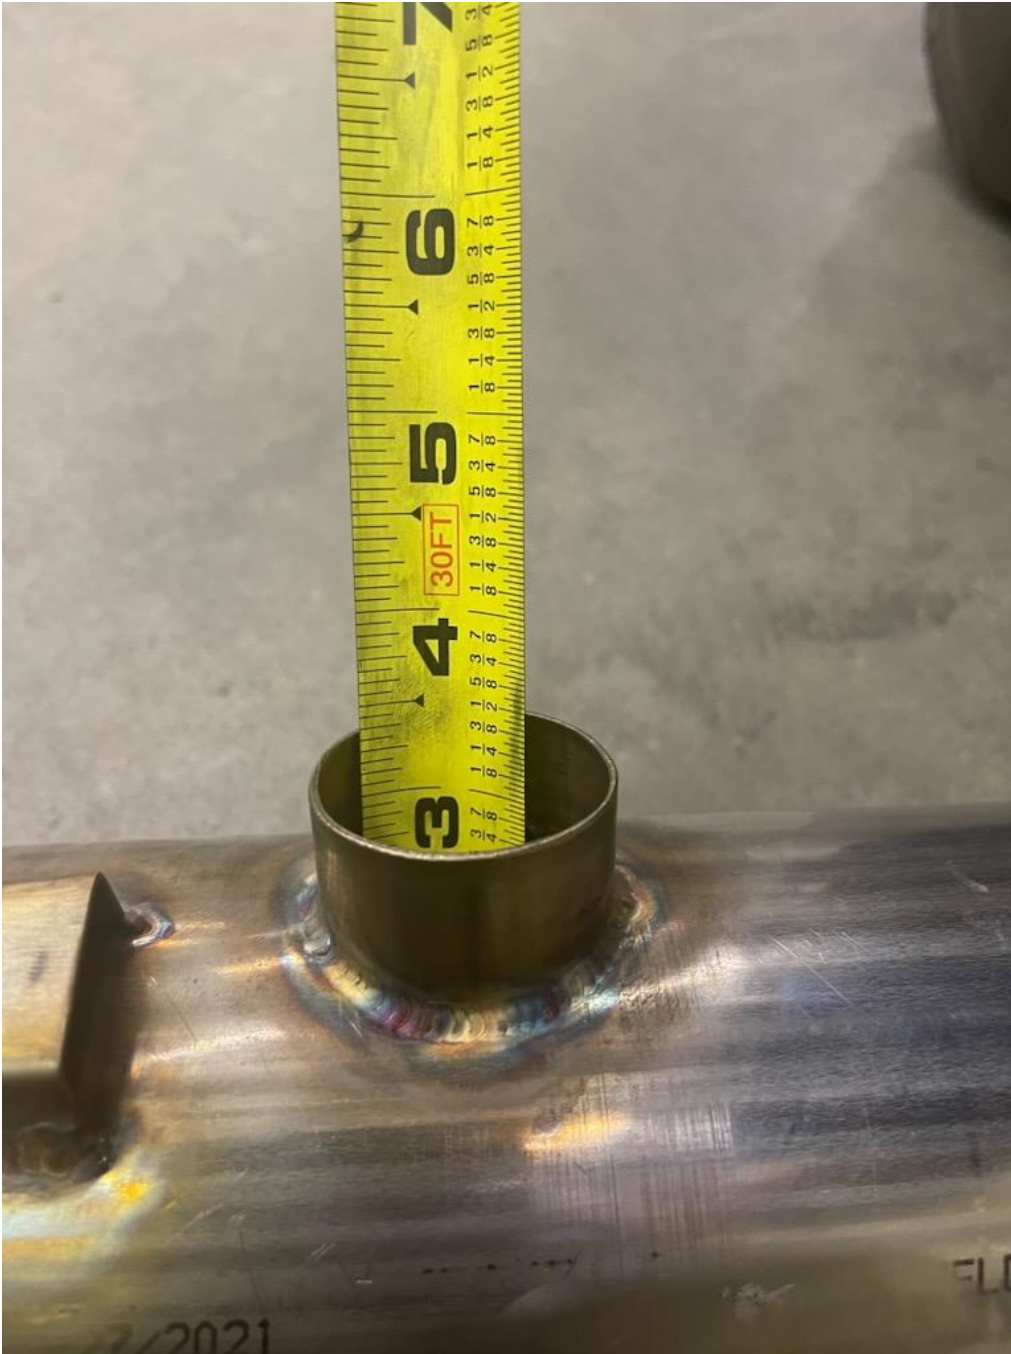
This measurement depicts the depth of the perforated tubing on a correct installation.
